Recommendations to Reduce Light Pollution and Energy Costs on the Campus of Bishop's University

BU DarkSky Initiative

Dr. Lorne Nelson
&
David Pawluczuk

December 21st, 2007
Bishop's University

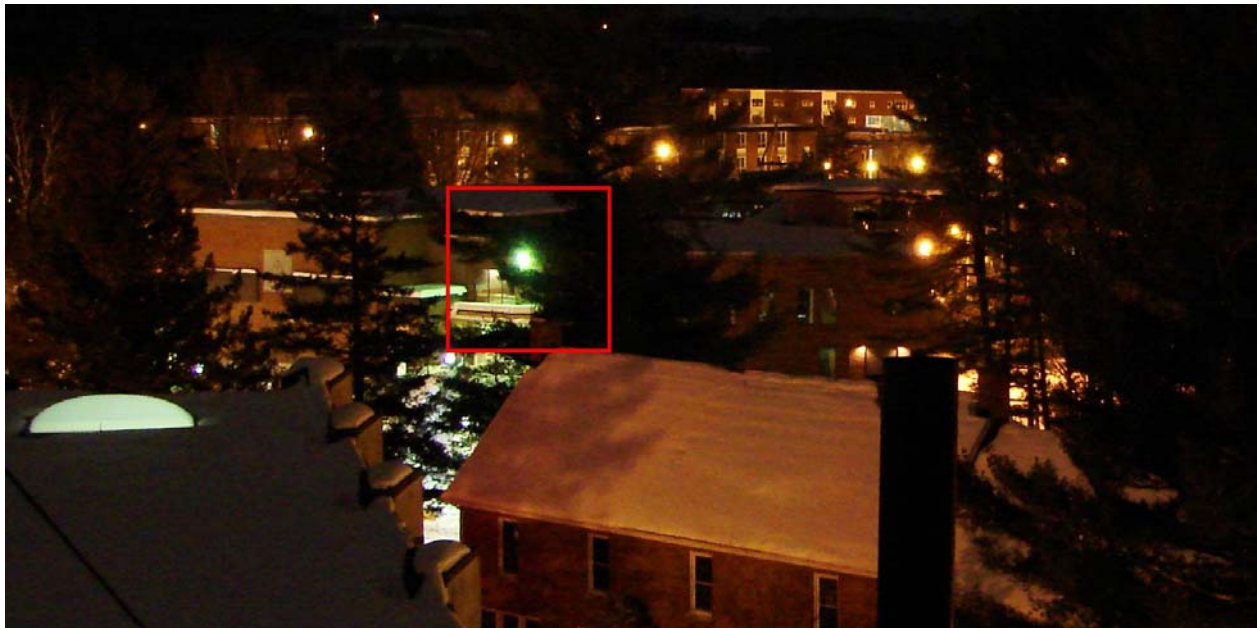
- MH22_CL01:

The following list of building and street lights are the largest contributors to light pollution at the Bishop's University Observatory from campus light sources. They are listed in descending order from the most detrimental light sources.

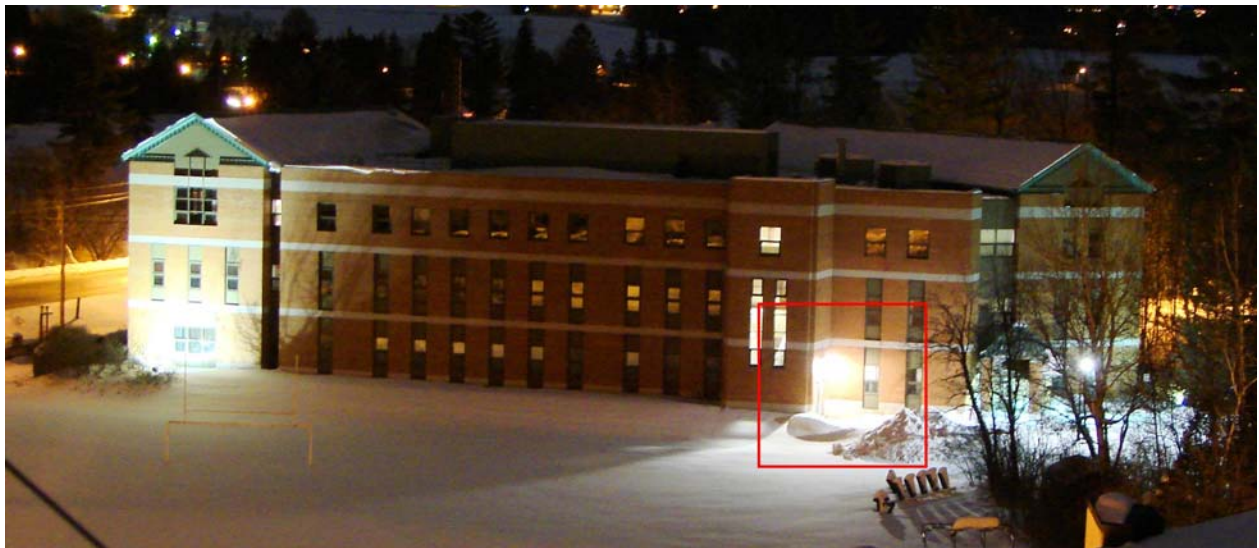
- CHM01:

The following list of building and street lights are the largest contributors to light pollution at the Bishop's University Observatory from Champlain Regional College. They are listed in descending order from the most detrimental light sources.

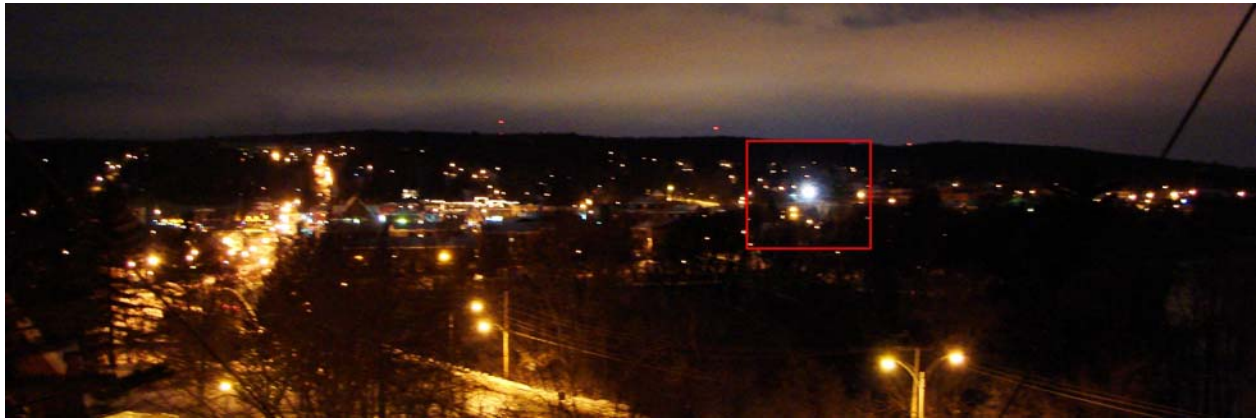
- LEN01:

The following list of building and street lights are the largest contributors to light pollution at the Bishop's University Observatory from the surrounding highway, bridge, and town. They are listed in descending order from the most detrimental light sources.
